WATERSHED-BASED PLAN FOR LAMBERT RUN OF THE WEST FORK RIVER

**Prepared By: The National Mine Land Reclamation Center
Funded By: West Virginia Department of Environmental Protection
March 2021**

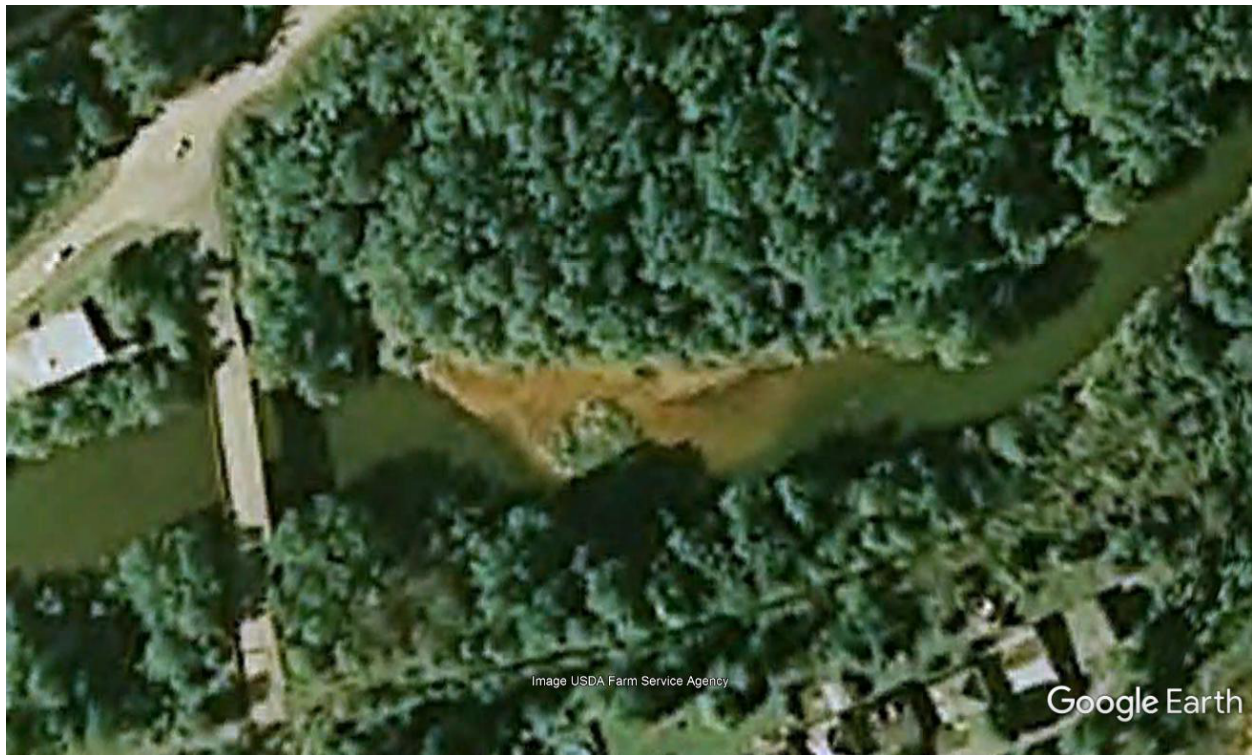
Figure 2: 2007 imagery of the mouth of Lambert Run in Google Earth reveals a plume of turbid, red water in the West Fork.

GFWS is developing a Water Trail to draw attention to the river as a recreation resource. Lambert Run, which in the 1990s and early 2000s added turbid red water to the West Fork (Figure 2) and is now adding almost entirely clear water (Figure 3), will be marked with an information kiosk for those paddling by. It will be an even better achievement to note once the remaining pollution is removed.

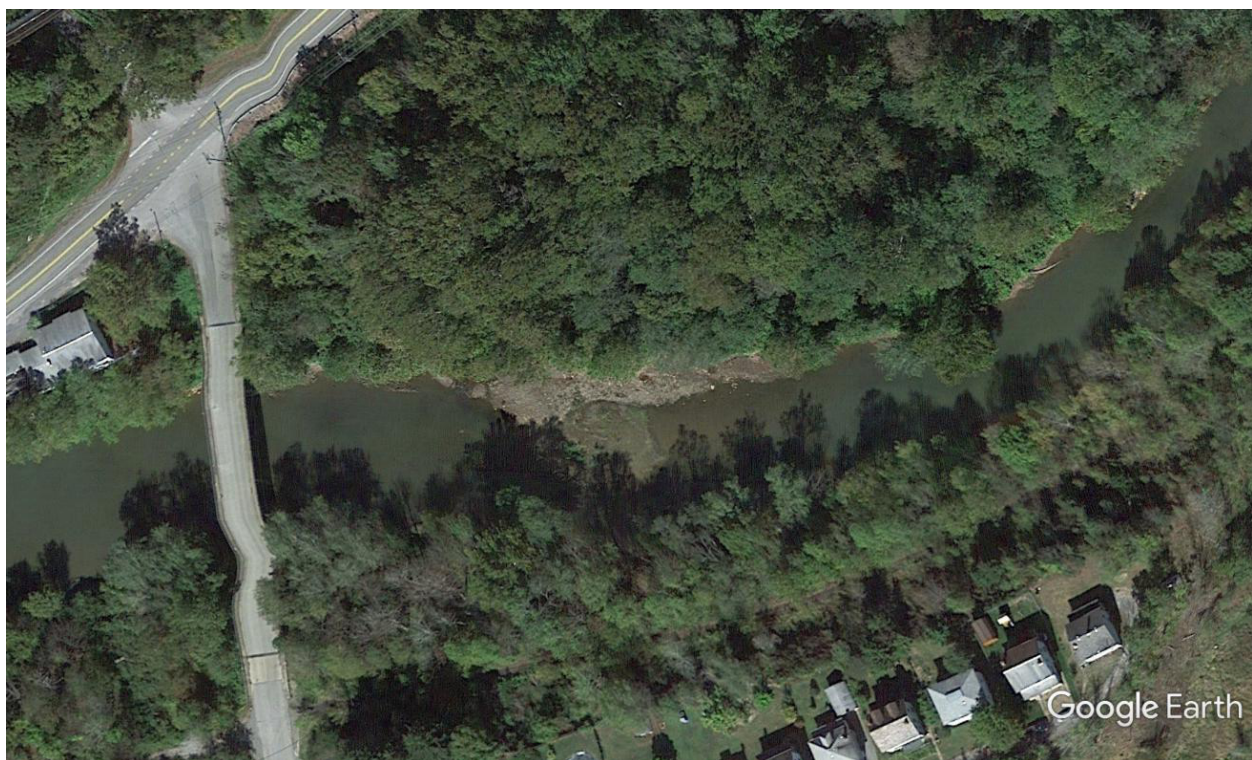
Figure 3: 2016 imagery at the same site shows a delta of sediment below Lambert Run, but relatively clear water.

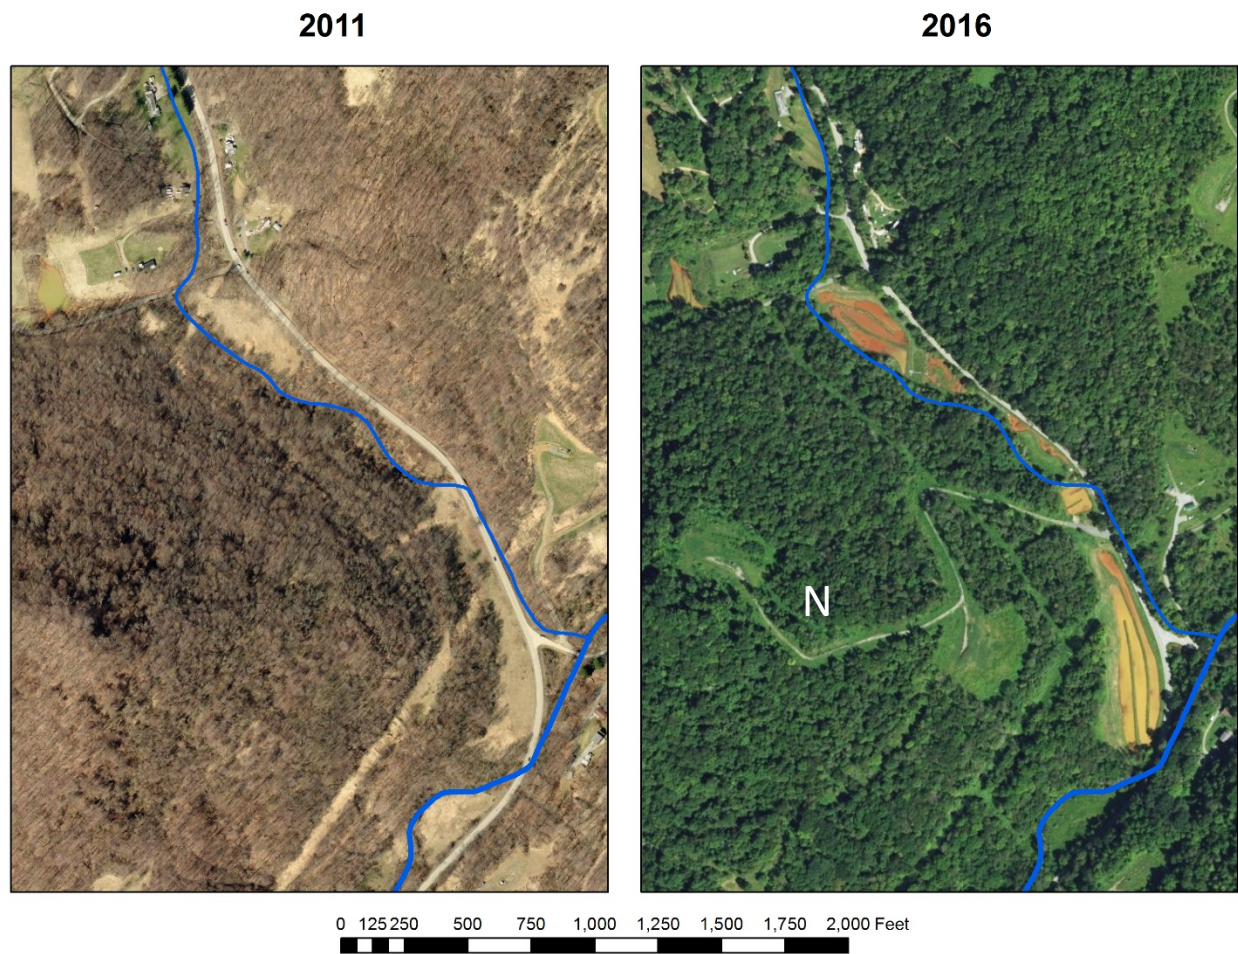
Figure 4: The Site 7 Project (right-hand picture) carries mine drainage from a pond that is visible at the top of the pictures directly to Lambert Run, which cuts across the bottom, right corner of the map, without flowing through UNT/RM 1.49.

Site 7 discharges 87,976 pounds of iron per year according to measurements by WVVRI. According to the TMDL, it discharges 53,373 pounds of iron per year, and accounts for 91% of the iron discharged by abandoned mines and 68% of the iron discharged by all nonpoint sources to Lambert Run. It is by far the largest source of iron to Lamberts Run. Without a successful solution to Site 7, Lambert Run cannot meet standards. A Site 7 project was built, but it removes only 70% of the iron from the Site 7 source. This plan calls for additional work at that site. The project changed the hydrology of the Lambert Run watershed in an important way. The Site 7 source is in subwatershed 1470 and discharged to UNT/Lambert Run RM 1.49. However, the Site 7 Project consists of a series of five wetlands through which the water from Site 7 flows directly to Lambert Run without entering UNT/RM 1.49 (Figure 4). While the project only removes 70% of Site 7's iron from Lambert Run, it removes 100% of Site 7's iron from SWS 1470 because of how the flow was changed. A few recent measurements of UNT/RM 1.49 have not violated the iron standard.

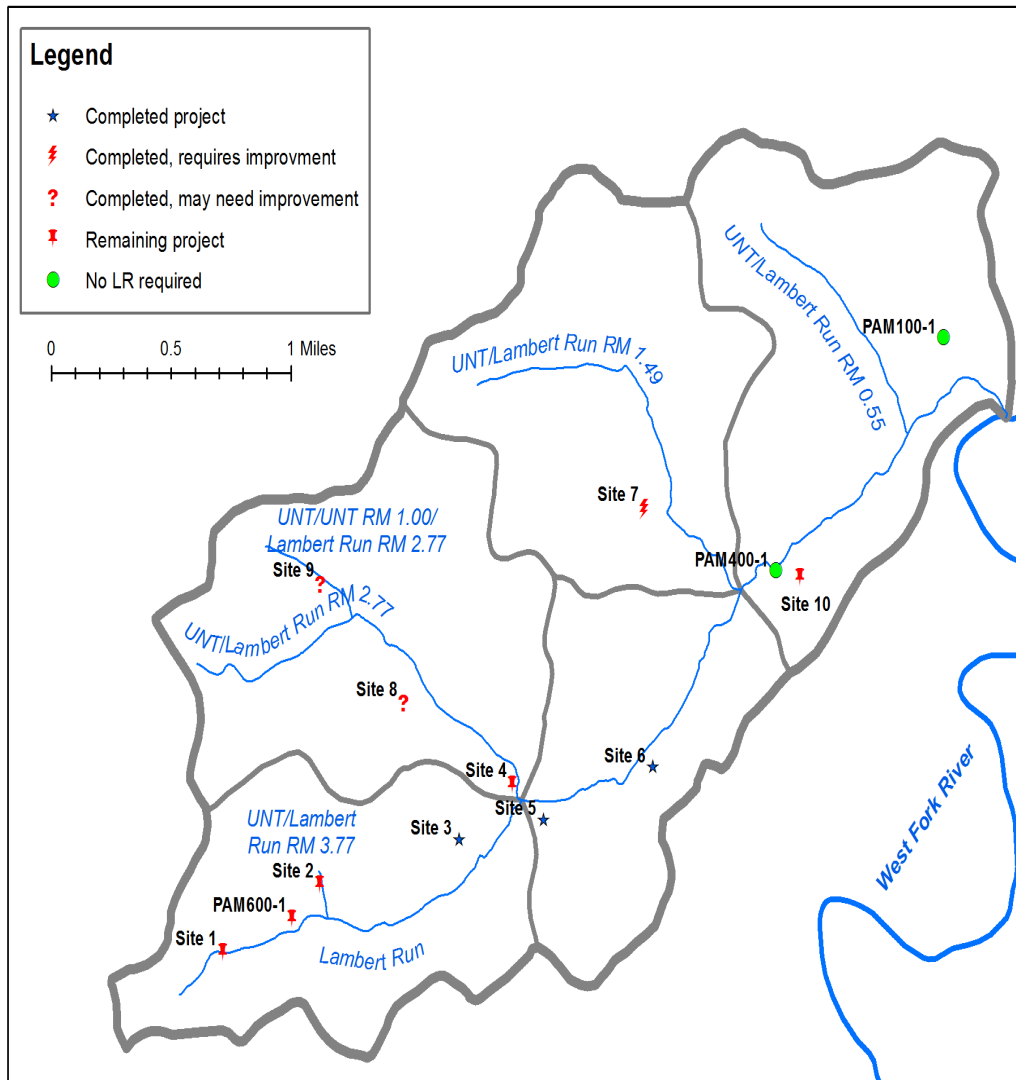
Figure 5: Lambert Run has four tributaries and one tributary to a tributary. Thirteen possible mine drainage sources have been identified, but no work is needed at six of them.

Lambert Run is 4.5 miles long and has four tributaries according to the United States Geological Service National Hydrography Dataset. There is also one tributary to one of the tributaries (Figure 5).

The Lambert Run WBP from 2003 identified ten abandoned mine drainage sources that contribute iron to the streams of the Lambert Run watershed (Table 5, Figure 5). The TMDL identified three additional sites that were not identified in the WBP.

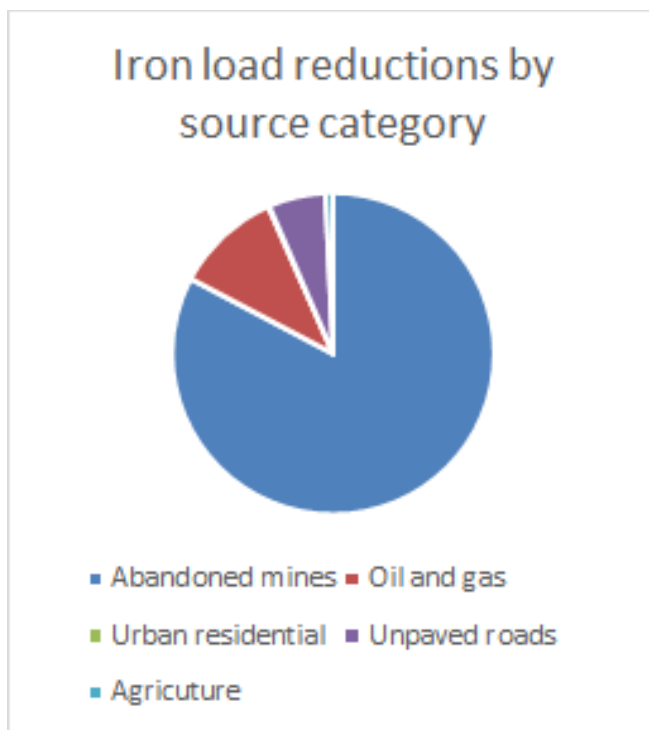
Figure 6: There are several causes of iron pollution in the Lambert Run watershed.

sources, and streambank erosion (WVDEP, 2014). The TMDL calls for reductions in iron loads from abandoned mines, oil and gas facilities, urban residential land, unpaved roads, and agriculture. The largest sources are abandoned mines (Figure 6).

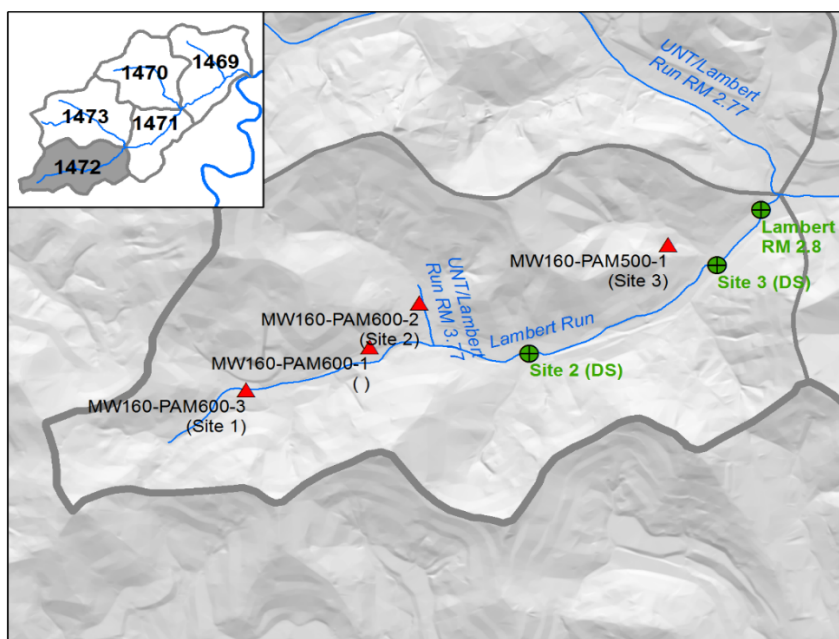
Figure 7: Subwatershed 1472 contains the headwaters of the mainstem of Lambert Run.

SWS 1472 is that portion of the watershed that drains to Lambert Run upstream from river mile 2.77 (Figure 7). Three discharges add iron to the water: Site 1, Site 2, and MW160-PAM600-1. The TMDL calls for a load reduction of 1,900 lbs/year (Table 8). The TMDL estimated that the largest source, Site 2, adds 1,600 lbs/year. This WBP calls for a project to reduce the mine drainage from Site 2 and monitoring to determine the condition of Lambert Run upstream from Site 2, and the loads from Site 1 and MW160-PAM600-1.

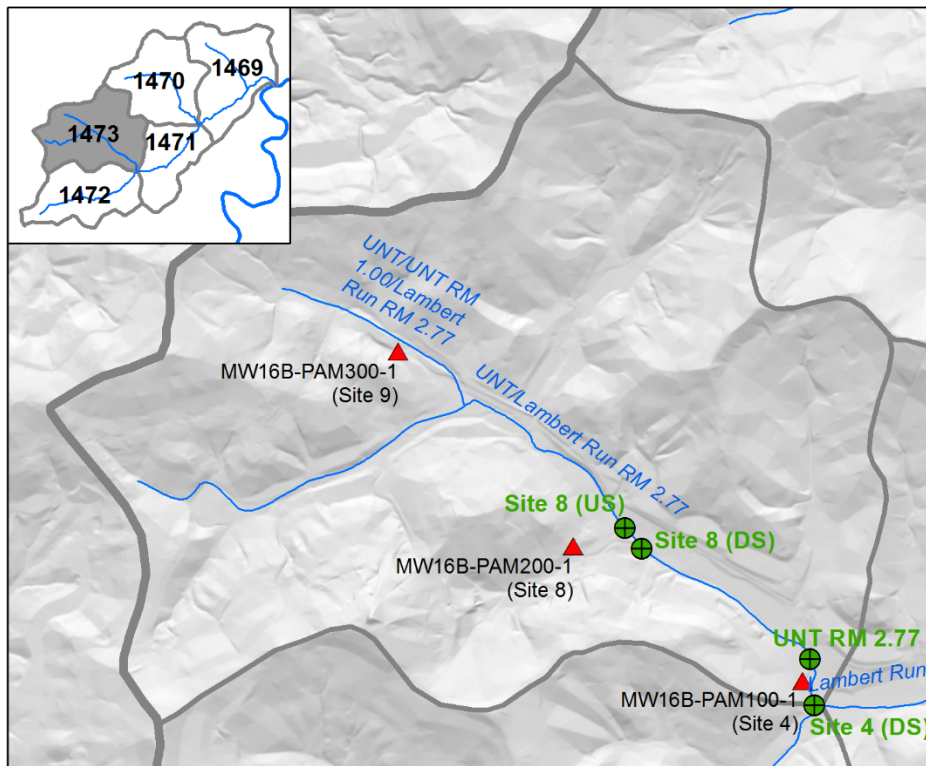
Figure 8: Subwatershed 1473 contains the unnamed tributary to Lambert Run at river mile 2.77.

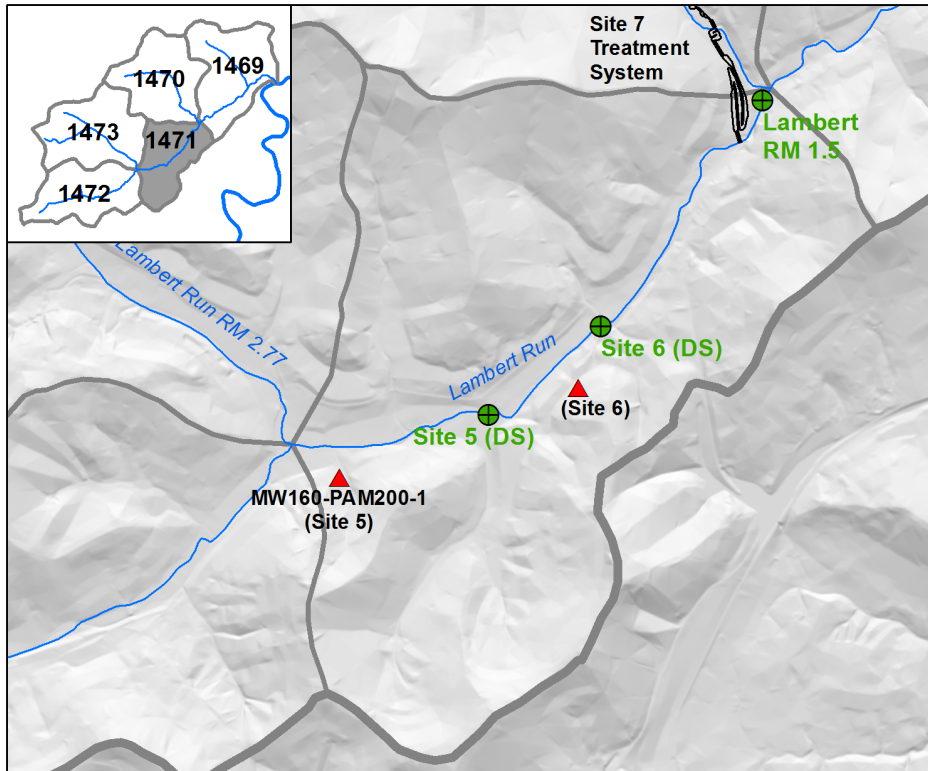
Figure 9: Reducing iron loads (lbs/year) measured at one source in SWS1471 will provide a greater reduction than that required by the TMDL model.:

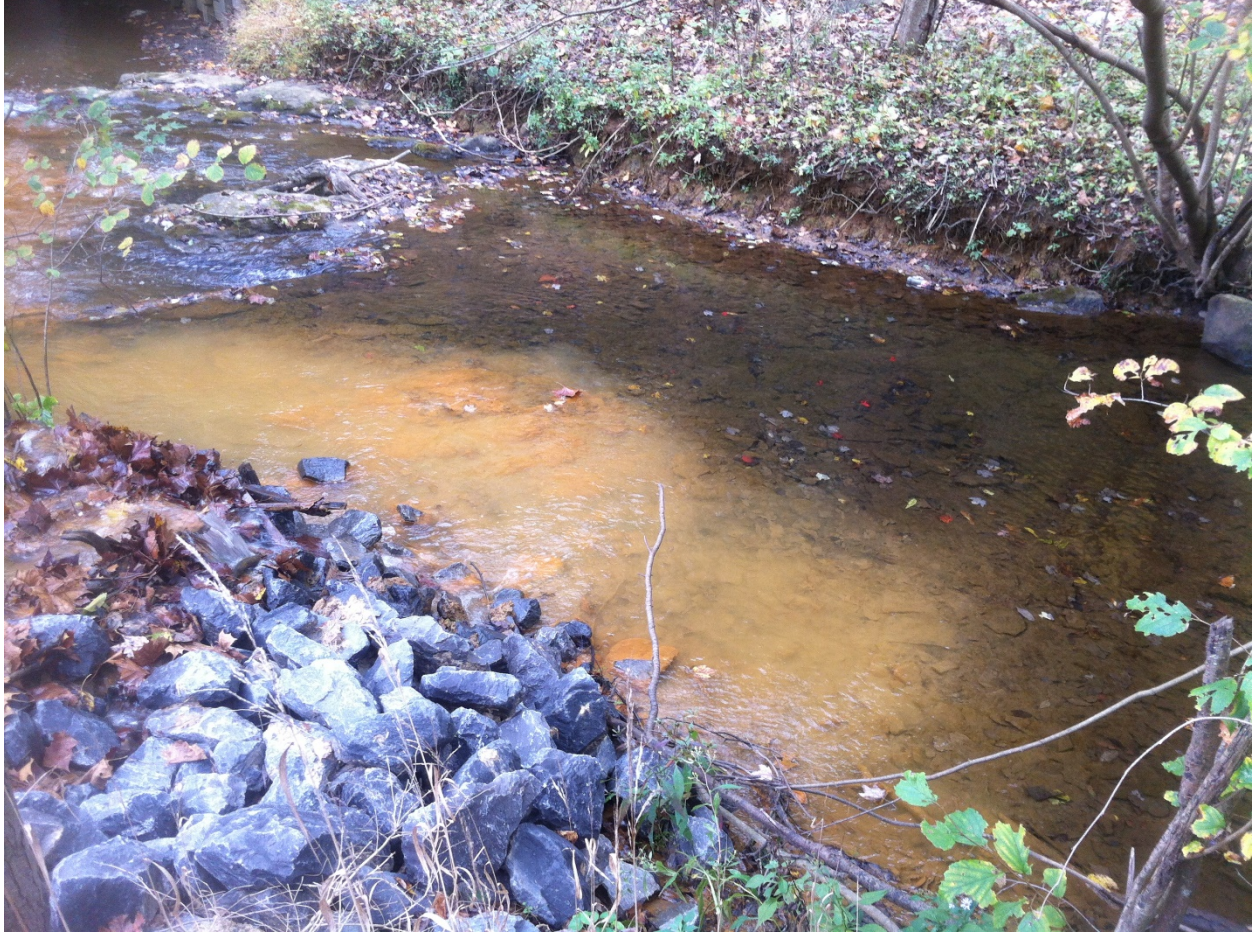
Figure 10: The discharge from the Site 7 project causes a plume of iron in Lambert Run near the downstream end of SWS 1471.

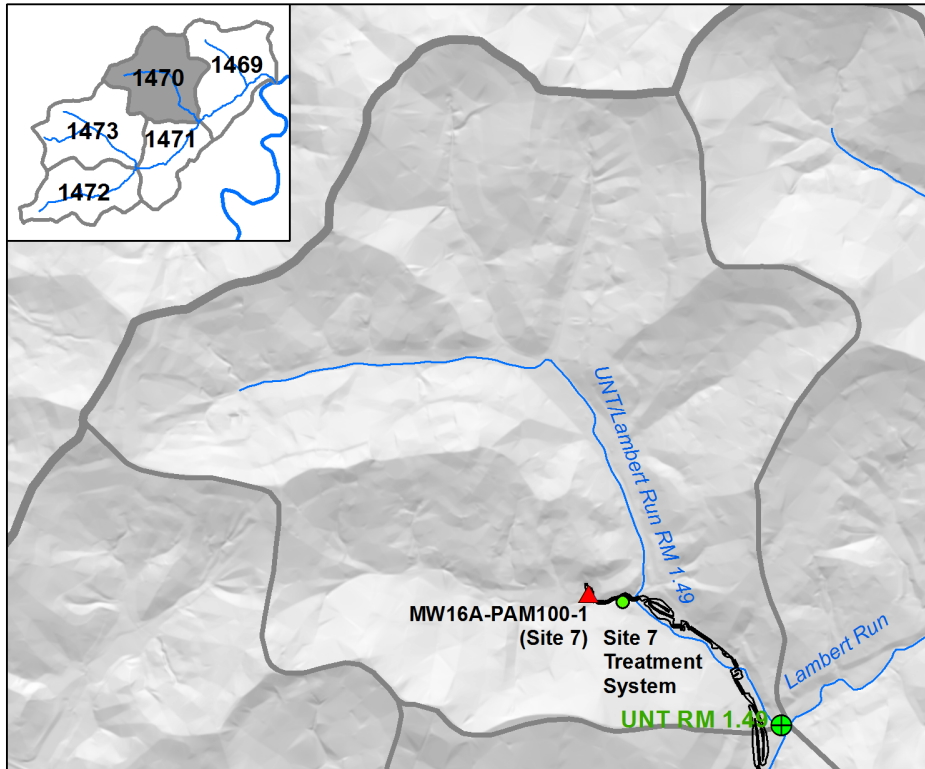
Figure 11: SWS 1470 contains only one mine drainage source, which has been diverted to the mainstem.

The Site 7 Project diverts the flow from Site 7 through approximately three acres of settling ponds and discharges it to the mainstem in SWS 1471 (Figure 12, Figure 11). The load from this discharge was 53,373 lbs/year according to the TMDL and 87,976 lbs/year according to WVVRI's measurements (Table 11). The one iron source in SWS 1470 is large but has been diverted to SWS 1471. Because the water is diverted to the Lambert Run mainstem, the entire load has been removed from SWS 1470 (Figure 12).

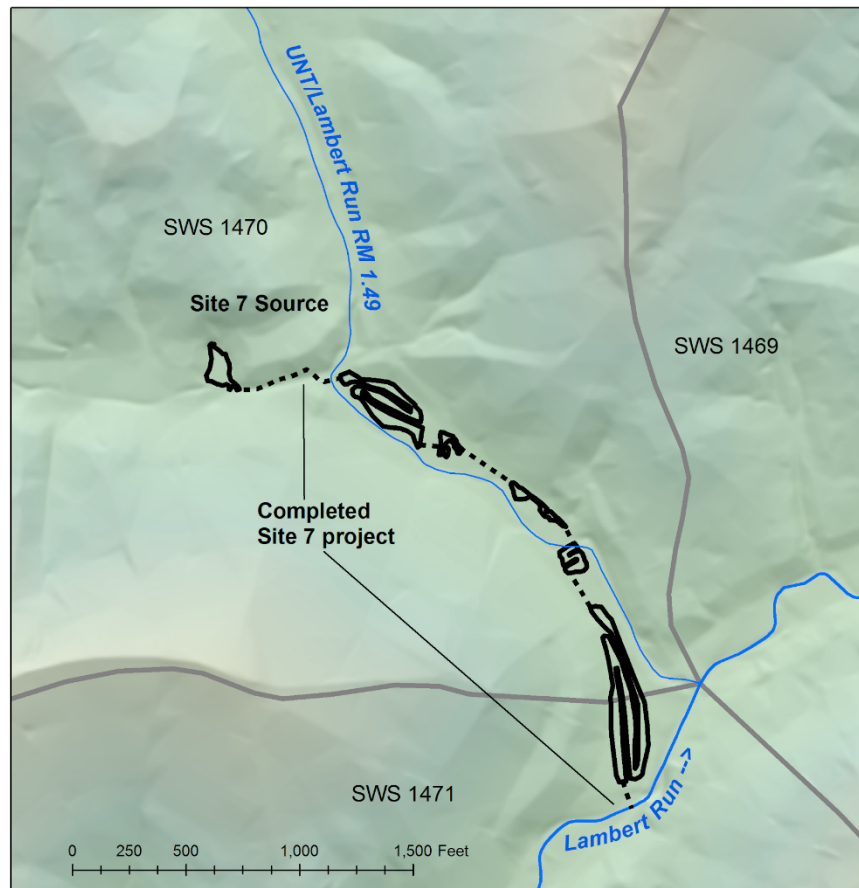
Figure 12: The Site 7 project diverts mine drainage from UNT/Lambert Run RM 1.49 directly to the mainstem.

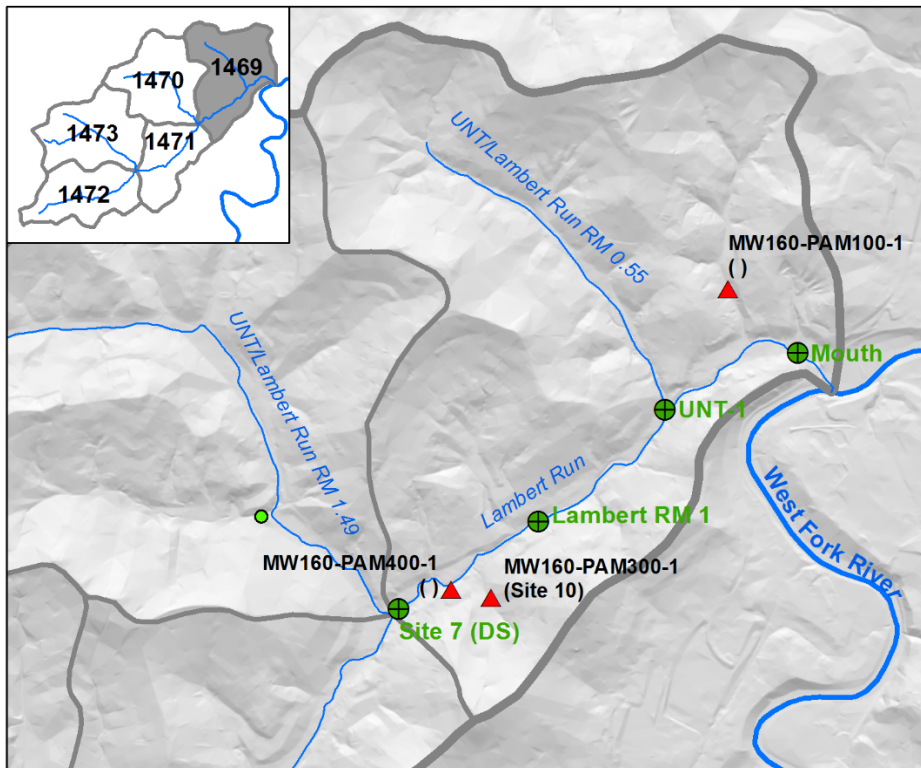
Figure 13: SWS 1469 contains three sources, two of which require not reductions.

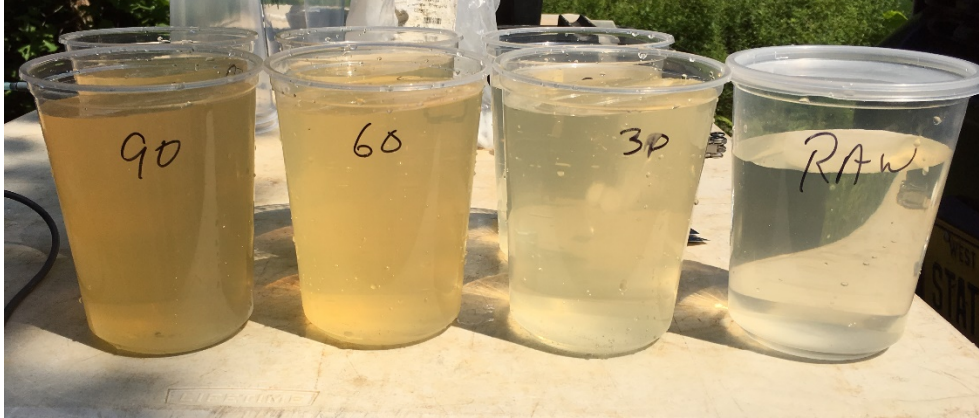
Figure 14: Samples receiving 30, 60, and 90 seconds of aeration with a Maelstrom oxidation unit show steadily increasing amounts of ferric hydroxide in suspension.

The problem posed by dissolved CO₂ can be solved by aerating the water and degassing the CO₂, but aeration aggravates the settling problem. Somerset Environmental Solutions aerated water from Site 7 for 30, 60, and 90 seconds and compared that water with an unaerated sample (Figure 14). Although increased aeration led to the appearance of more precipitate, there was little evidence of material settling to the bottom of the sample. Small particles created by rapid oxidation sink out of the water column even more slowly because of their size.

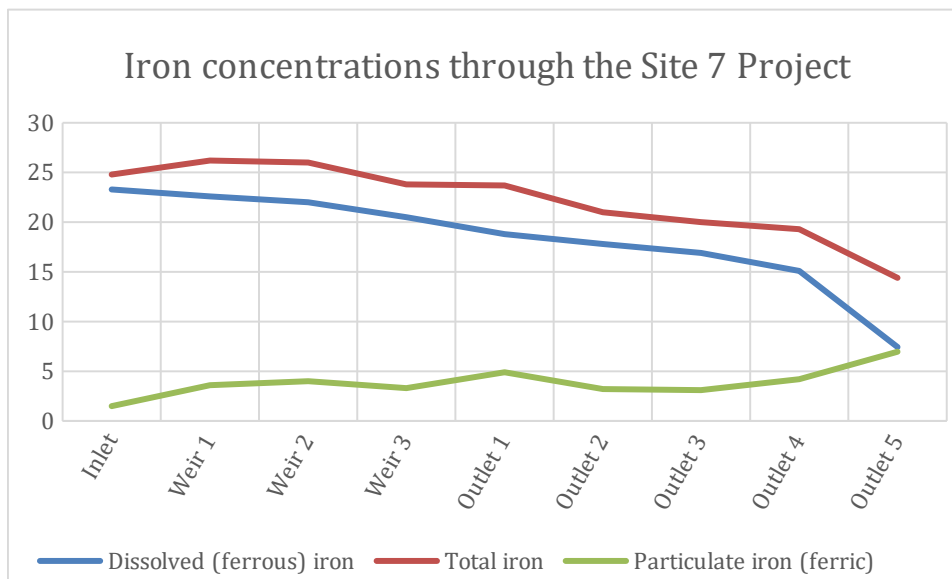
Figure 15: The chemistry of the Site 7 water changes as it flows through the existing project.

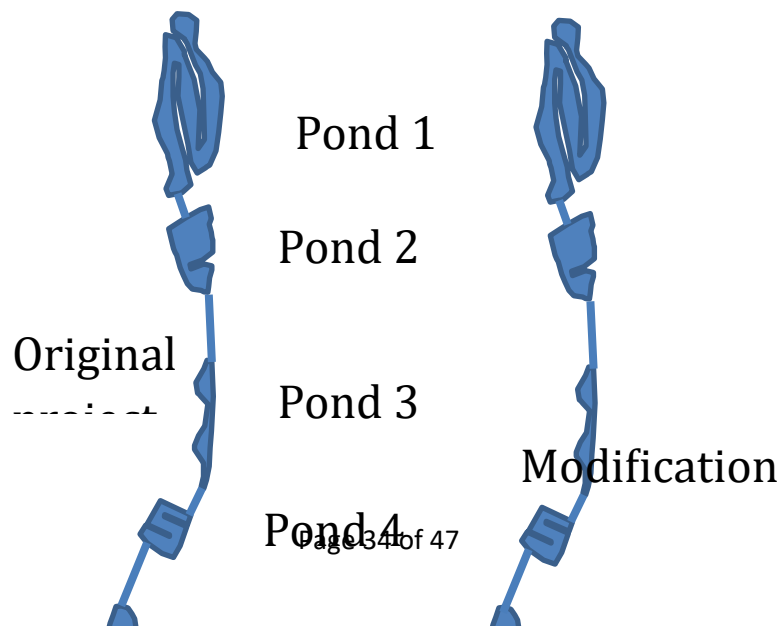
Figure 16: We propose to modify the Site 7 Project by reexcavating Pond 5 to make it wider, slower, shallower, and more densely vegetated.

WVWRI data indicated that UNT/Lambert Run RM 2.77 is impaired, particularly just downstream of the Site 8 Project. It is not certain whether maintenance at Site 8 and Site 9 completely solved the problem. If additional monitoring indicates that these projects are not removing enough iron, then upgrades will be carried out. Upgrades will include modification of existing ponds to accommodate slower, shallower, more thickly vegetated wetlands.
